JR
Inspections

Property Type: Single Family **Stories:** Two **Approximate Age:** 75 years old

Home Inspection

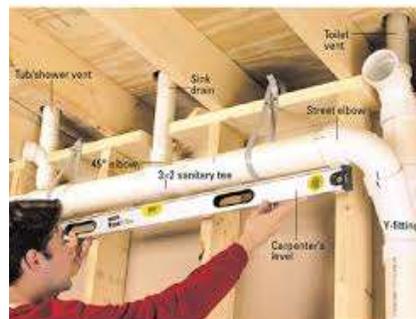
Drain, Waste & Vent Lines

Most of the drain lines were not accessible, concealed behind walls therefore not inspected. Visible sections of the drain, waste and vent lines were intact and no leaks were observed at the time of the inspection.

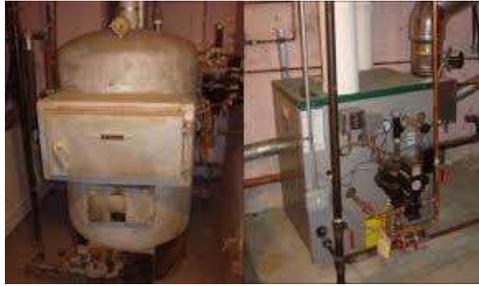
Heating System

Our evaluation of the heating system is both visual and functional provided power and or fuel is supplied to the system. A forced hot air furnace was observed in the basement of the home. The furnace appeared to have been manufactured in December 2010 and likely installed shortly thereafter. The estimated age of this furnace is approximately 7-8 years old. The mid-range efficiency furnace and its components were intact at the time of the inspection except as noted. The furnace ignited when tested. The metal flue vent connector at the top of the furnace was intact and all joints were tightly secured. The flue vent discharged to a fire brick chimney and was sealed properly. Clients are encouraged to purchase a home warranty plan, since furnaces can require repair at any time.

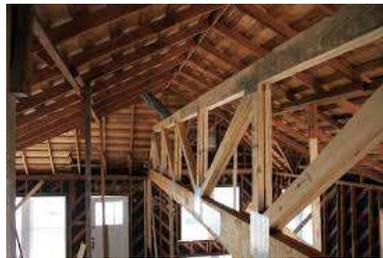
Support Members

The support members of a wood frame house include the beams, sills and columns.

The main beam was constructed with a double 2in. x 10in. nailed together. The beam was held up with 4in. dia. steel columns. Each column was resting on a separate concrete footing.
